Highway Deep-Patch Geogrid Applications

Written by Brian M. Collins, Eli Cuelho – Published in Geosynthetics Magazine , June/July 2018 Volume 36 Number 3 – Distributed by Carthage Mills

Three Before and After Studies of Road/Embankment Solutions

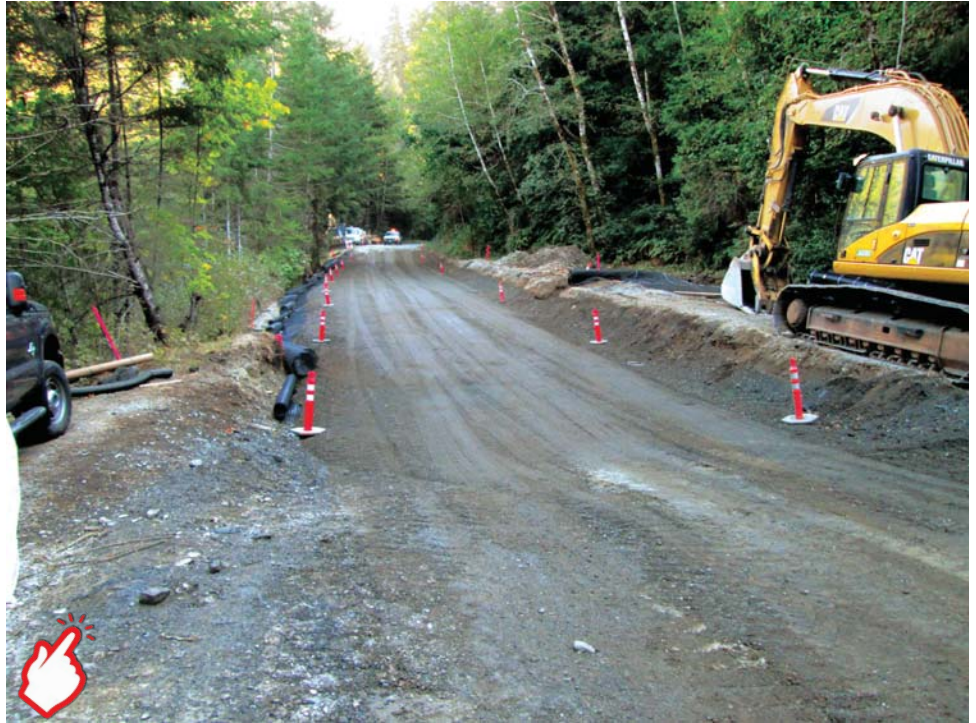
FIGURE 1 Construction of the Agness Road deep patch in Oregon in 2014. The second layer of geogrid is installed and covered with gravel.

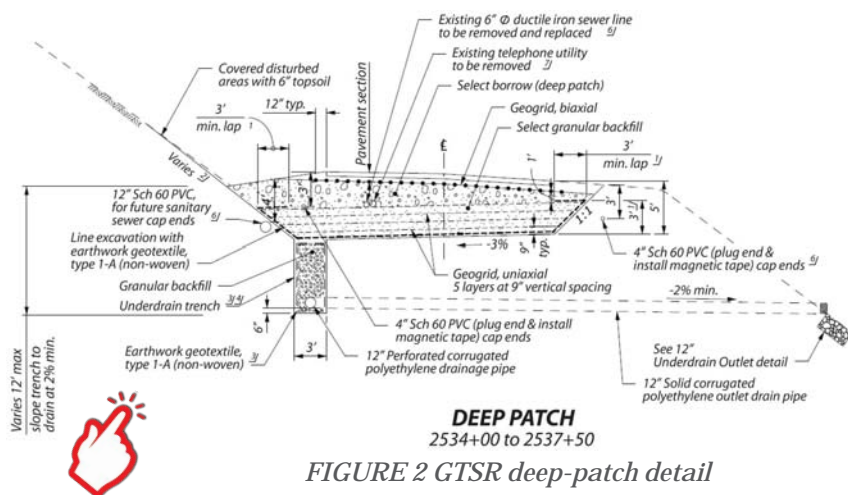
FIGURE 2 GTSR deep-patch detail

Deep patches and underdrains were recommended to mitigate the landsliding at the two sites (Collins 2012). The deep-patch reinforcement consisted of five layers of uniaxial geogrid placed at 9-inch (23-cm) vertical spacing (**Figure 2**). The underdrain extends as much as 12 feet (4 m) below the ditch line. The existing horizontal drains were jetted during construction.

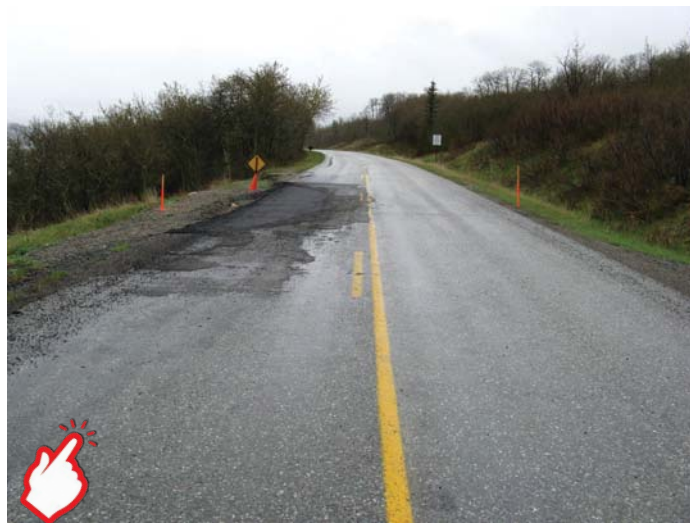
FIGURE 3a Before photograph in May 2011 showing GTSR deep-patch location.

Figure 3a shows the road before construction. The GTSR deep patch was constructed in April 2014. Since construction, no additional pavement distress has been observed (**Figure 3b**).

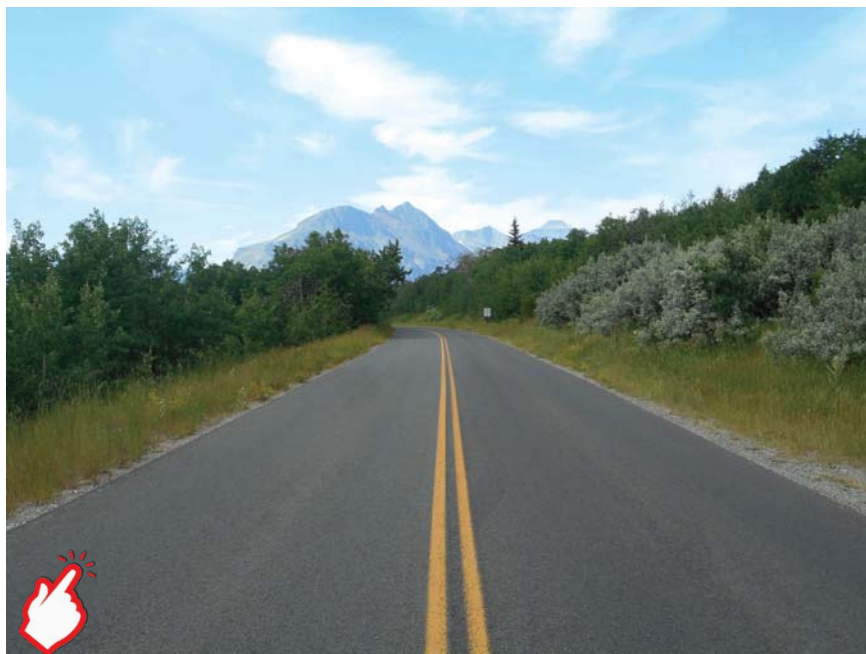
FIGURE 3b After photograph in July 2017 showing GTSR deep-patch location

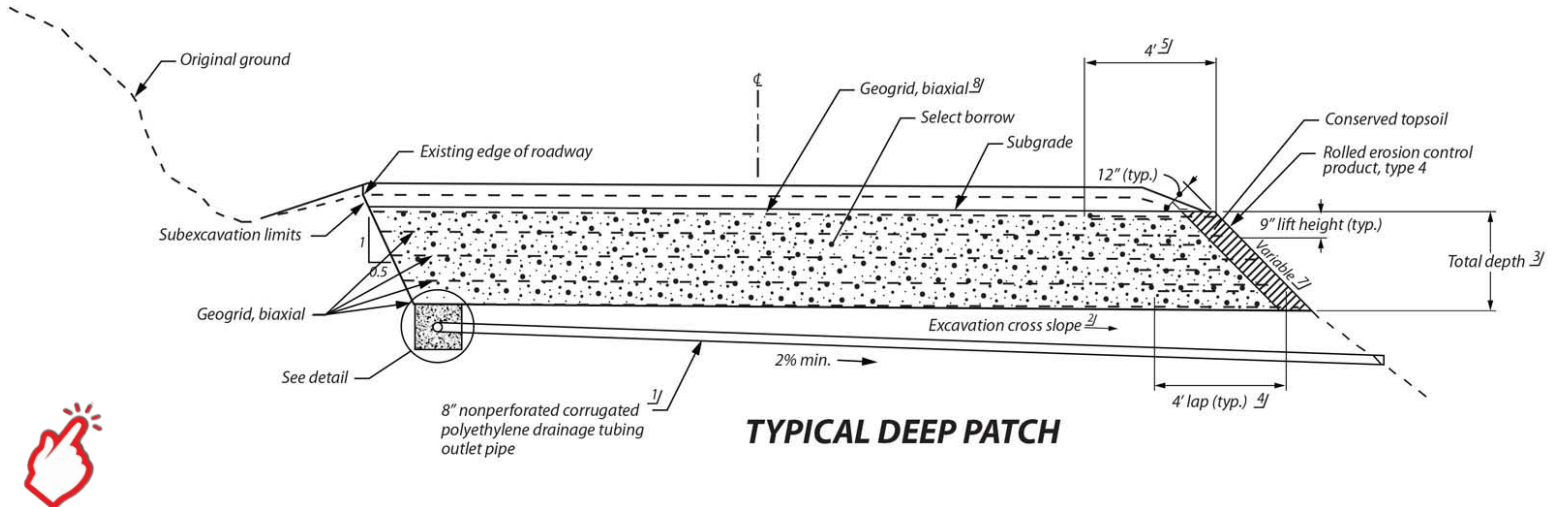
FIGURE 4 Middle Fork Snoqualmie River Road deep-patch detail.

The typical deep-patch detail used on MFSRR illustrated both 3-foot (1-m) deep patches with five layers of biaxial geogrid at 9-inch (23-cm) vertical spacing and 4.5-foot (1.4-m) deep patch with seven layers of biaxial geogrid at 9-inch (23-cm) vertical spacing (**Figure 4**). The deep patch at the Milepost 10 Landslides was 4.5-feet (1.4-m) deep.

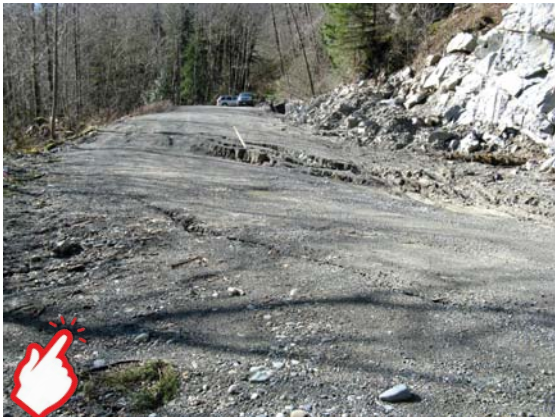
FIGURE 5a Before photograph in March 2015 of the MFSRR Milepost 10 deep patch.

A U.S. Geological Survey gauging station near the Milepost 10 Landslides was used to develop a correlation between the occurrence of damaged sites in the project corridor with heavy precipitation events (Collins 2016). Damage was observed at the Milepost 10 Landslides in March 2015 following heavy precipitation events over the 2014–2015 winter (**Figure 5a**). The deep patch at the Milepost 10 Landslides was completed in May 2015, but not paved. During the winter of 2015–2016,

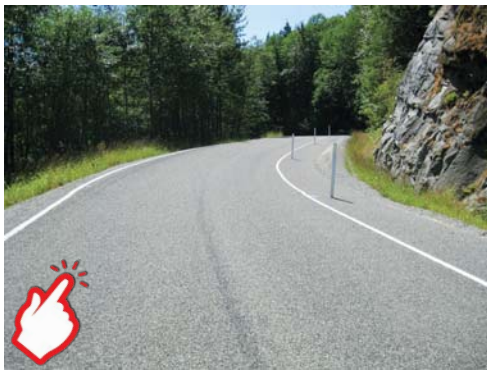
FIGURE 5b After photograph in July 2017 of the MFSRR Milepost 10 deep patch.

multiple heavy precipitation events occurred, resulting in damage at other sites along the project, but no displacement was observed in the roadway at the Milepost 10 Landslides. The chip seal was placed in June 2017 (**Figure 5b**).

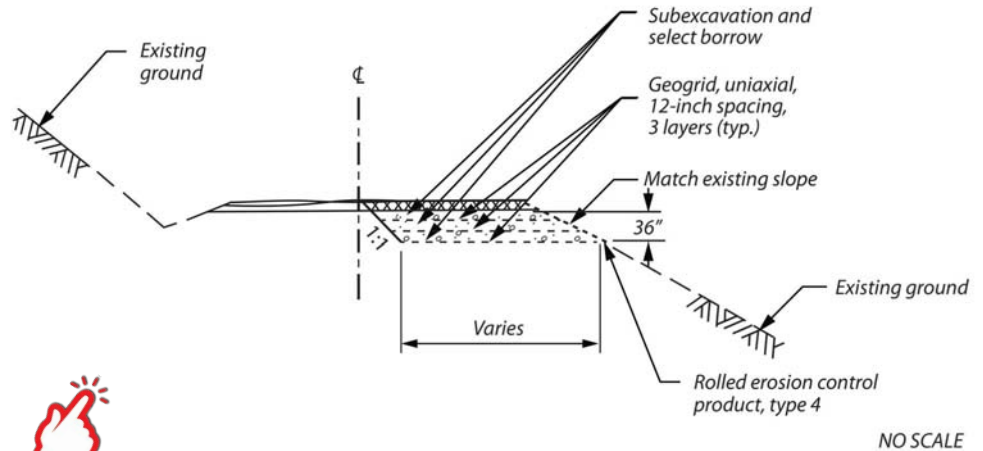
FIGURE 6 2011 Agness Road deep-patch detail

Agness Road (locally known as Jerry Flat Road) is a narrow two-lane forest highway through mountainous terrain that goes from Gold Beach to Agness, Oregon, in the southwestern corner of the state. In 2011 cracking and pavement distortion was observed at milepost 13.2. In September 2011 a half-width deep patch was constructed. The deep patch was 3-feet (1-m) deep, with three layers of geogrid at 12-inch

(30-cm) vertical spacing (**Figure 6**). In 2012 the shoulder (outside the limits of the deep patch) dropped about 2 feet (0.6 m). The shoulder was rebuilt with a rock fill that same year. By 2013 the site had begun to move again, and distress was observed in the pavement. Another project was initiated to construct a more robust deep patch at the site. The new deep patch was 187-feet (57-m) long and 5.5-feet (1.7-m) deep with seven layers of biaxial geogrid with 9-inch (23-cm) vertical spacing and extended the full road width (**Figure 7**). An underdrain system was installed that extended 1 foot (0.3 m) below the deep patch. A pipe in the middle of the landslide was removed, and the ditch water was directed to another pipe outside the limits of the landslide.

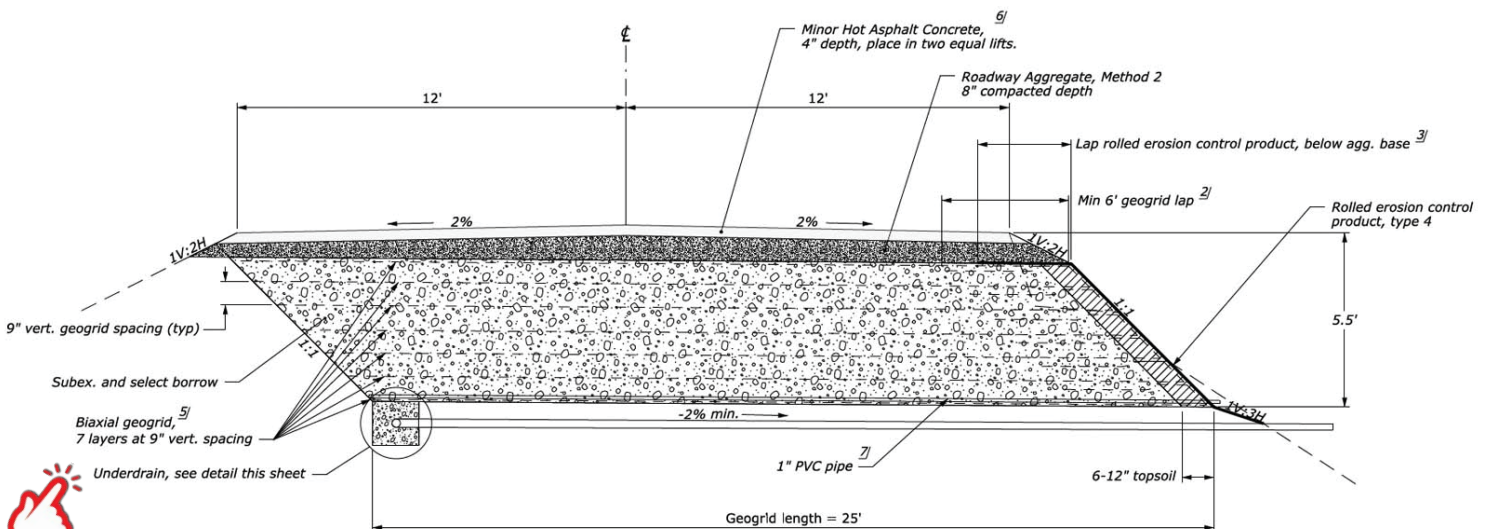
FIGURE 7 2014 Agness Road deep-patch detail

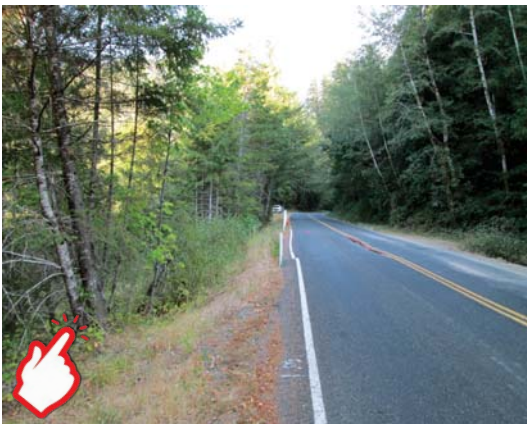
FIGURE 8a Agness Road site before deep-patch construction in September 2014.

By September 2014 the roadway had displaced nearly 6 inches (15 cm) along the centerline, with the most significant displacement at

the back end of the previously installed deep patch (**Figure 8a**). The deep patch was constructed in October 2014 (**Figure 8b**).

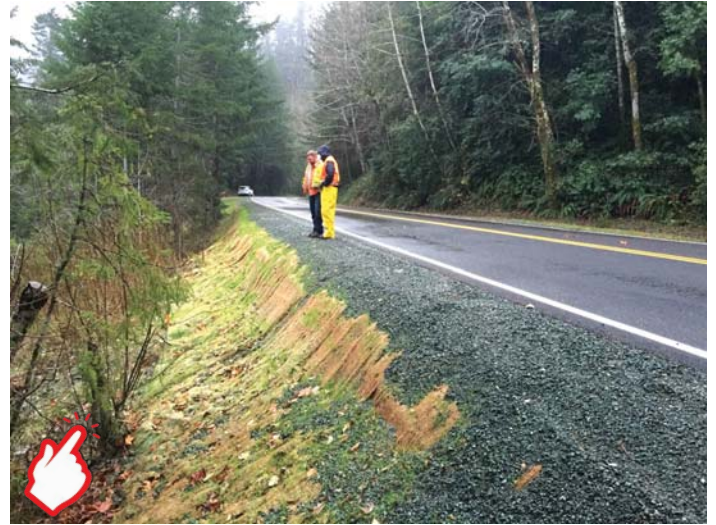
FIGURE 8b Agness Road site after deep-patch construction in December 2014.

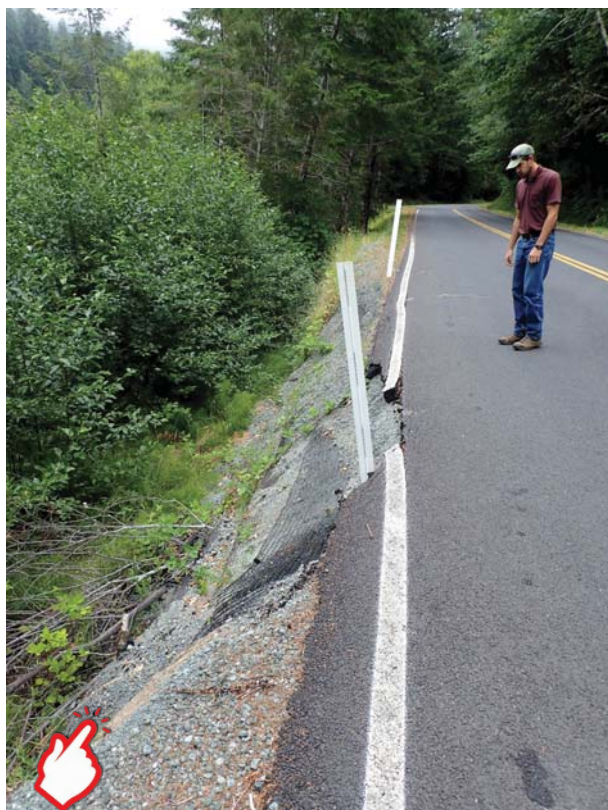
FIGURE 9 Agness Road deformation in July 2017.

In July 2017 the asphalt concrete pavement had fallen off outside the crack and the dip was still a total of about 2 inches (5 cm) (**Figure 9**). The ShapeArray indicated that total deformation was about 42 inches (107 cm) at the outside edge of the deep patch. We visually estimated that the ground in front of the deep patch had dropped more than 6 feet (1.8 m) in the time since the first fix in September 2011 and the July 2017 site visit.
